MEMORANDUM

SUBJECT: Stage II Vapor Recovery Enforcement Policy- Husky 3360 Breakaway Identification

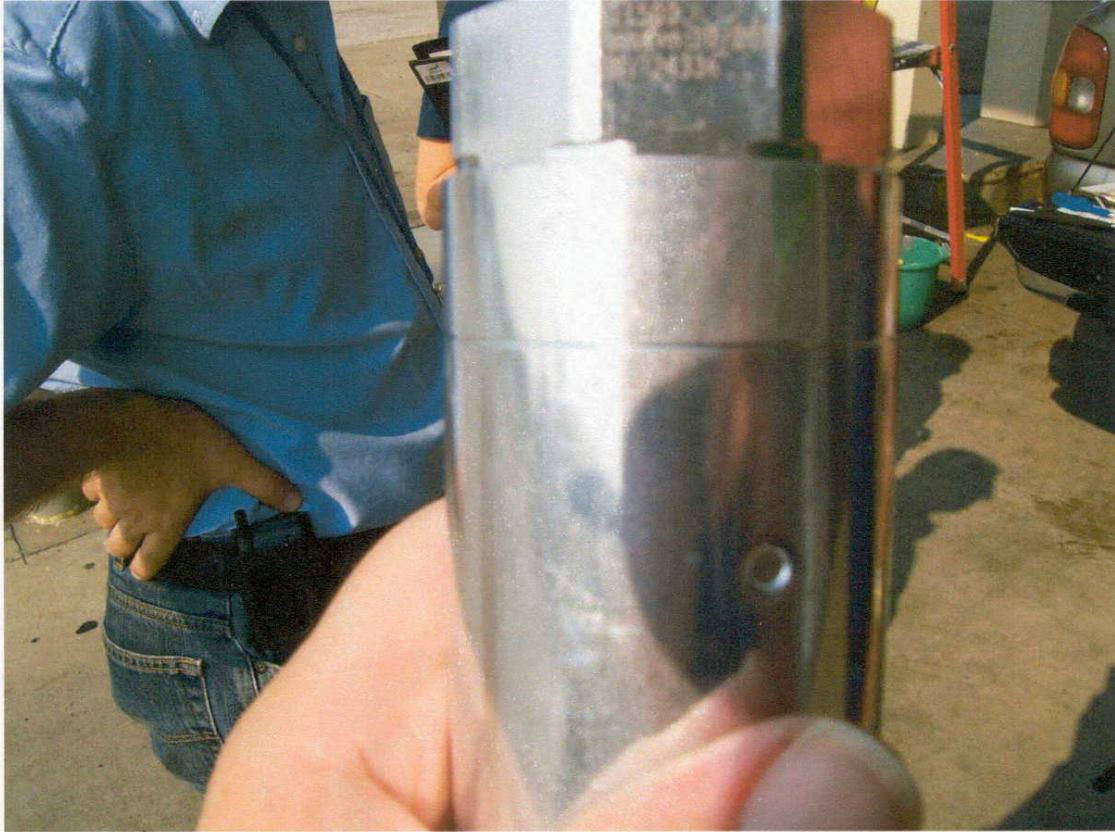
HUSKY 3360 BREAKAWAY

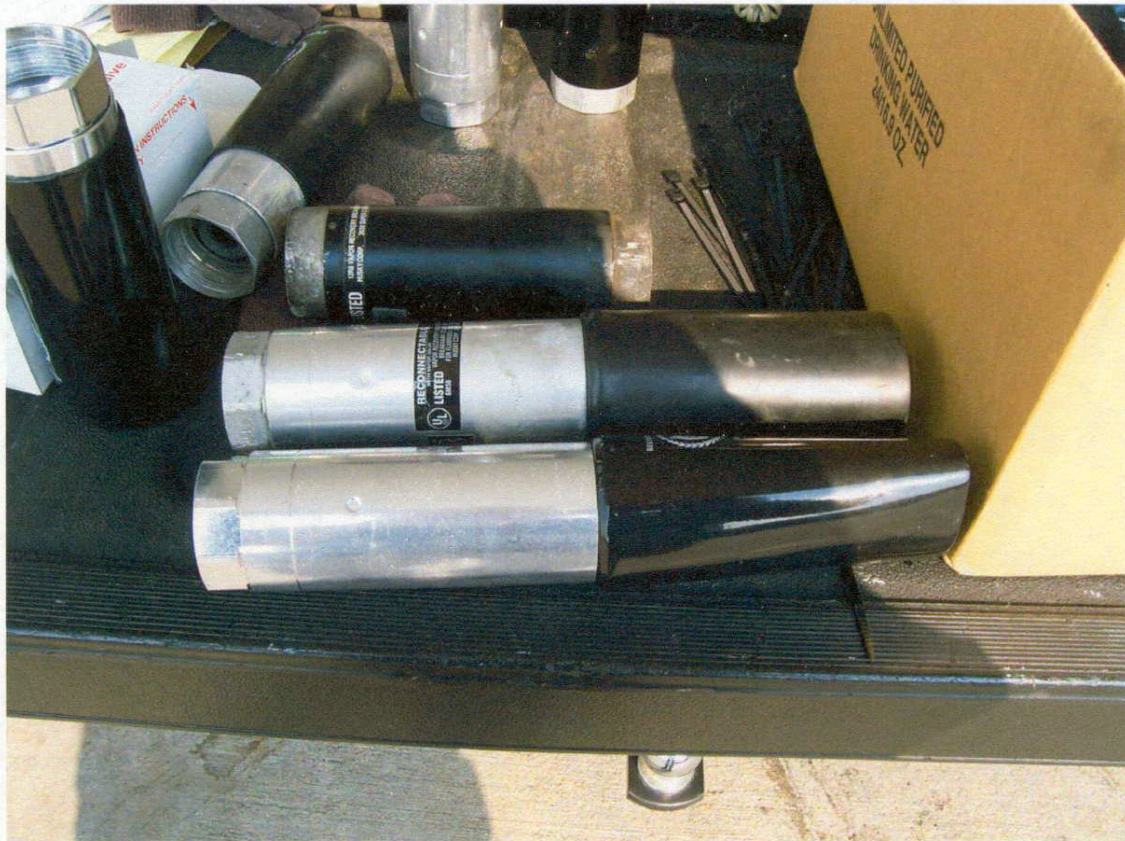
HUSKY 3360 BREAKAWAY
(Two in forefront)

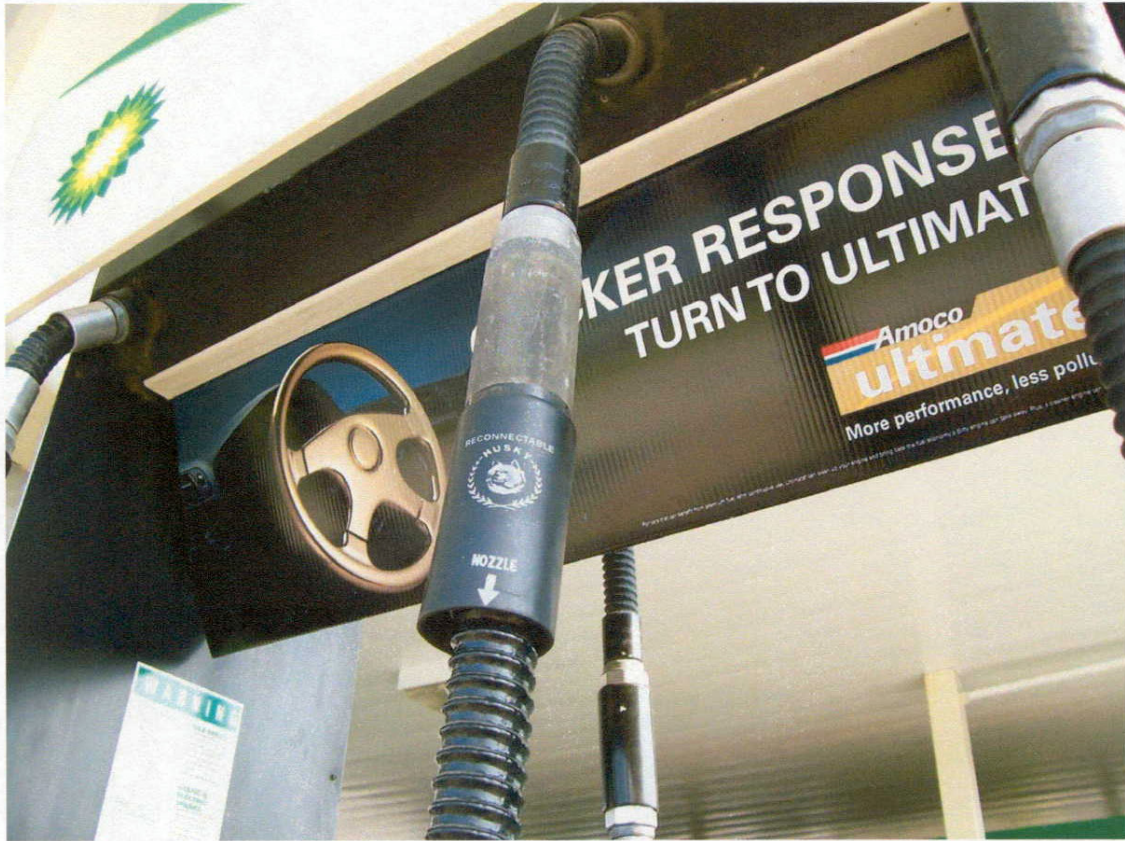
HUSKY 3030 BREAKAWAY
(Unapproved)

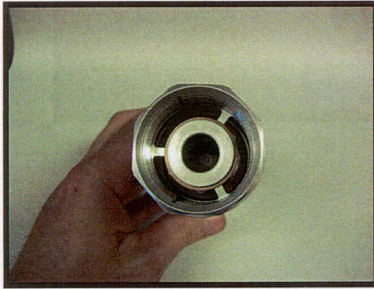
All the 3360VR's have an end fitting with **8 sides**. (Reference Pictorial)

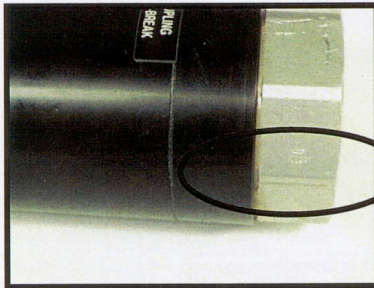
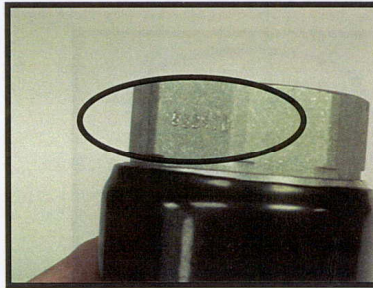
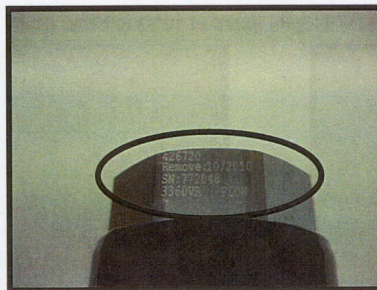
The end fitting is stamped with a **code date** (MM YY or MM T YY), or a **6 digit lot number** (xxxxxx), or a **remove by date**. (Reference Pictorial)

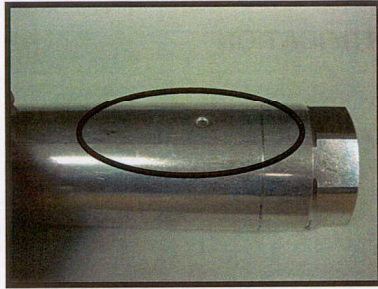
If the code date is older than 12/93 it will be necessary to look for **dimples** in the metal sleeve or at the label under the plastic cover to identify it as a 3360VR. (Reference Pictorial)

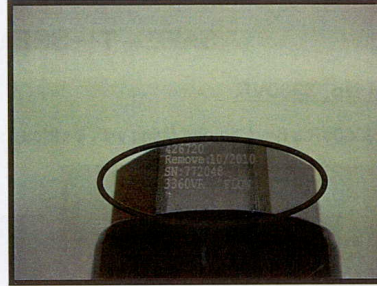
All units with **lot numbers** and the **remove by date** markings are 3360VRs. (Reference Pictorial). All current production is being marked with 3360VR and the **flow direction arrow** on the end fitting. (Reference Pictorial)

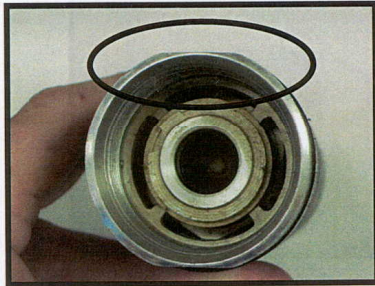
All units with less than 8 sides are 3030's. (Reference Pictorial)

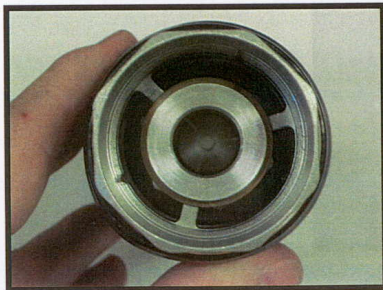
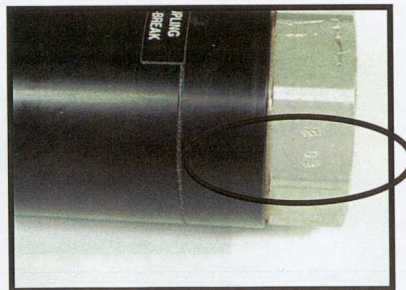
The 3030's with **8 sides** were stamped with **code dates of 12/93** or older. (Reference Pictorial)
